INDOOR AIR QUALITY ASSESSMENT

**North Attleborough Middle School
564 Landry Avenue
North Attleborough, Massachusetts**

Prepared by:
Massachusetts Department of Public Health
Bureau of Environmental Health Assessment
Emergency Response/Indoor Air Quality Program
February 2004

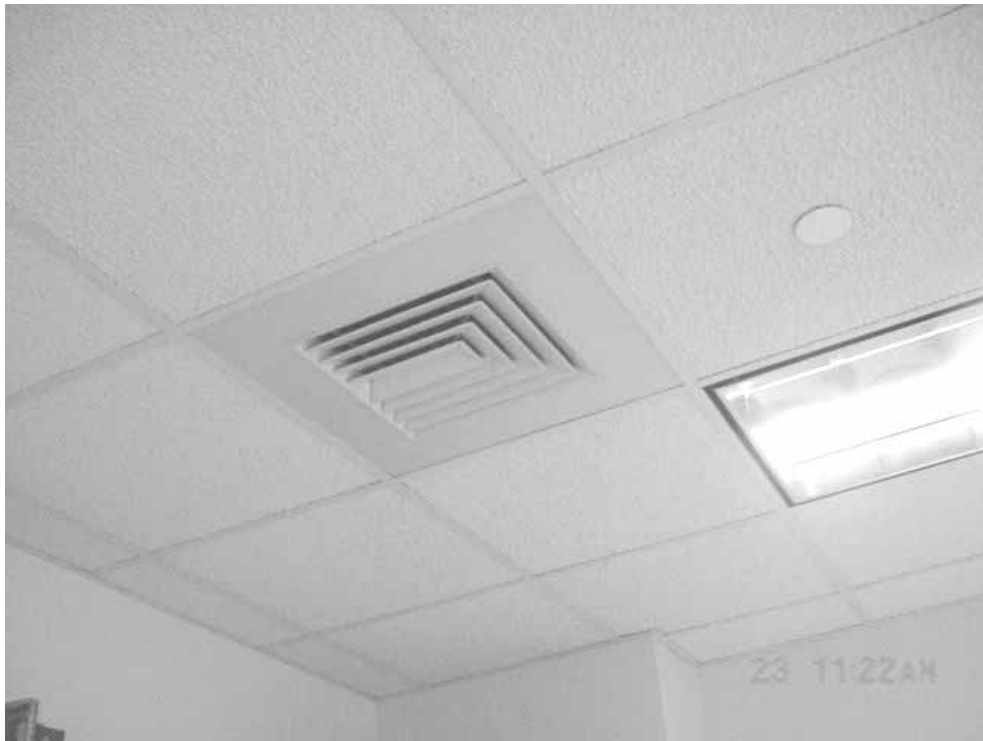
Picture 1

Fresh Air Diffuser for HVAC System

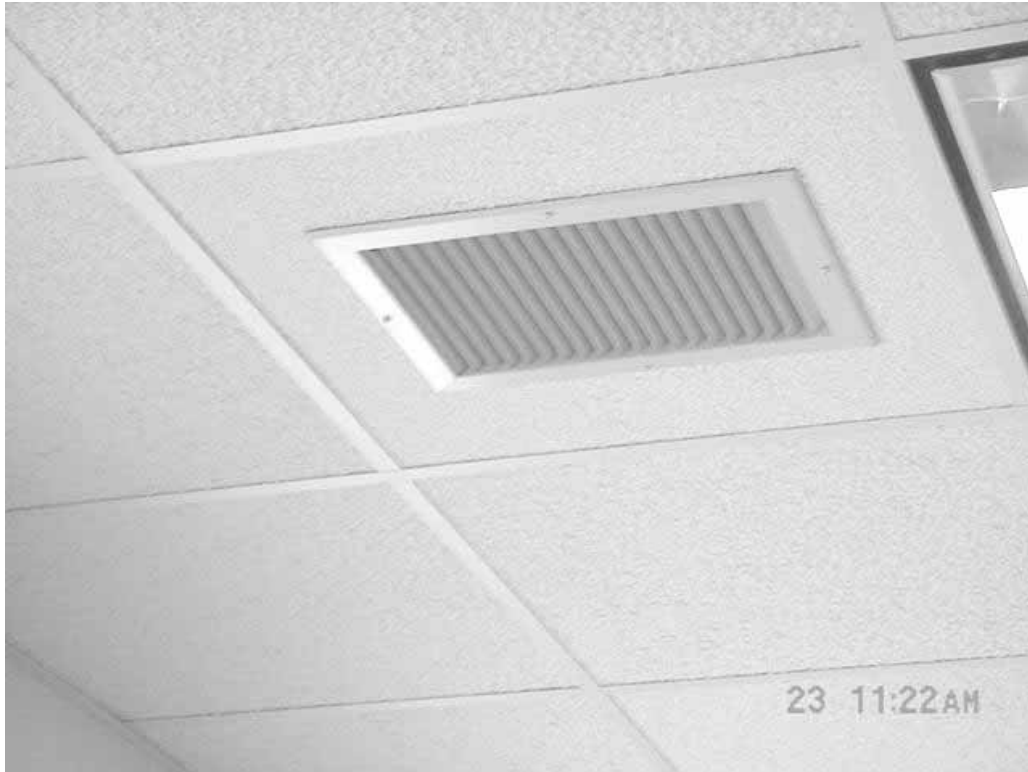
Picture 2

Return Vent for HVAC System

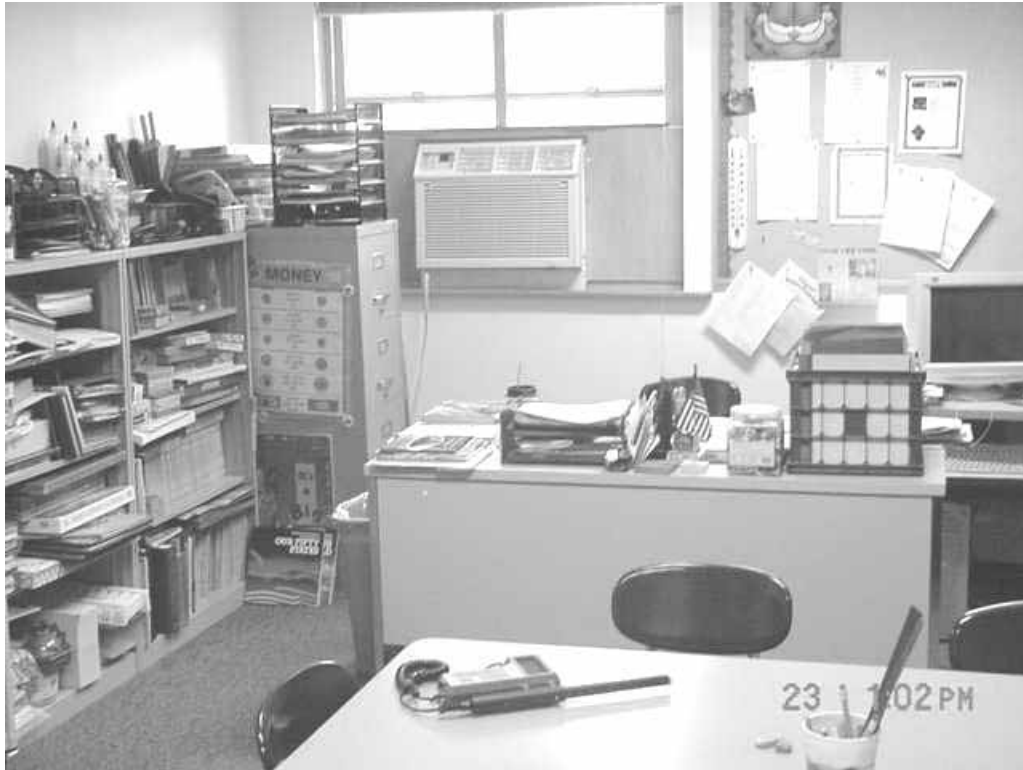
Picture 3

maintained in a range of 70° F to 78° F in order to provide for the comfort of building occupants. In many cases concerning indoor air quality, fluctuations of temperature in occupied spaces are typically experienced, even in a building with an adequate fresh air supply. Building occupants expressed a variety of temperature control/comfort complaints. Complaints included excess heat in the media center and locker room offices, as well as cold temperatures in classroom 300. An occupant's desk in classroom 300 was located in front of a window-mounted air conditioner (AC) (Picture 3). The assessment occurred on a cold, windy day. BEHA staff detected drafts around the AC unit, indicating pathways for cold air to enter the classroom from outside.

Proximity of Occupants Desk to “Drafty” Window Mounted AC

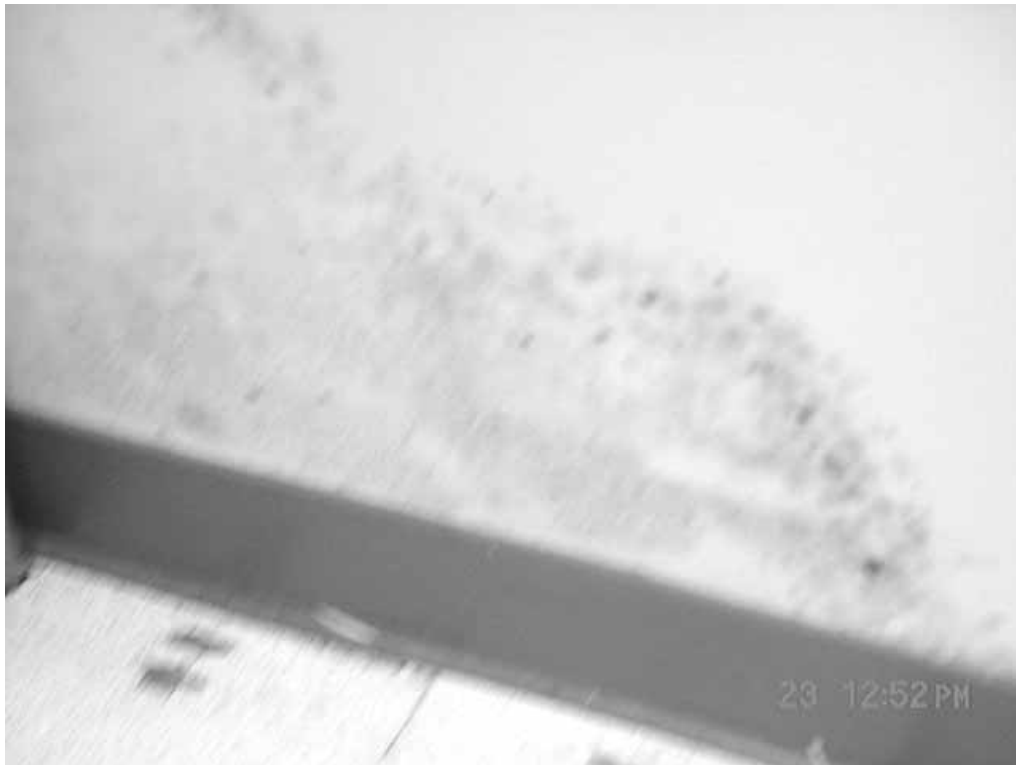
Picture 4

BEHA staff did observe active mold growth on GW in a storage closet in room 301 as a result of a leak in the HVAC system (Picture 4). At the time of the assessment, BEHA staff recommended that the water damaged GW be removed and replaced. [Note: In a subsequent conversation with Mr. Wing, he reported that all water damaged building materials in the storage room were removed and replaced].

Mold Growth (as Indicated by Dark Stains) on GW in Classroom 301 Storeroom

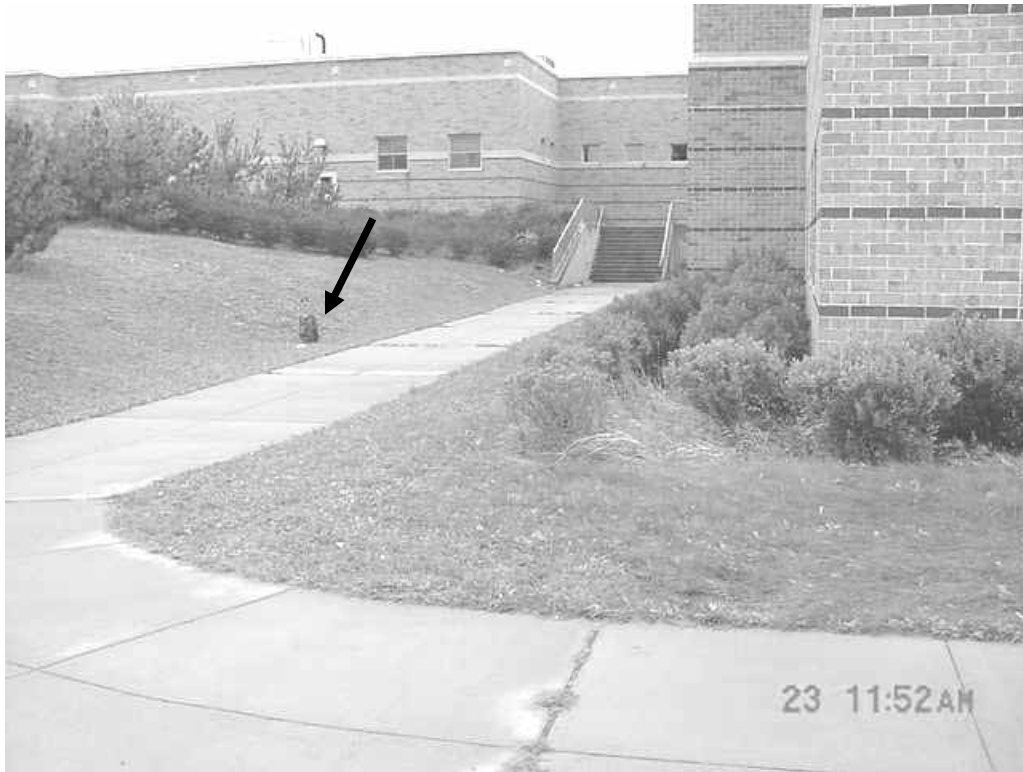
Picture 5

School officials reported that the building has problems with water pooling on the ground outside of classrooms 120-122 during heavy rains (Picture 5). Town and school officials are reportedly investigating plans to improve drainage in the area. In addition, shrubbery and other plants were growing in close proximity to foundation walls (Picture 6). The combination of the downgradient position of the building and the growth of roots against the exterior walls can bring moisture in contact with wall brick. Plant roots can eventually penetrate the brick, leading to cracks and/or fissures in the below ground level foundation. Over time, this process can undermine the integrity of the building envelope and provide a means of water entry into the building through capillary action through foundation concrete and masonry (Lstiburek & Brennan, 2001).

Sloped Area Outside Classrooms 120-122, Note Shrubbery in Close Proximity to the Exterior Brick Bag Placed to Indicate Position of Drain

4. Continue working with town officials to improve drainage and prevent water pooling on grounds outside of classrooms 120-122. Consider building up landscape against the building to create a berm.

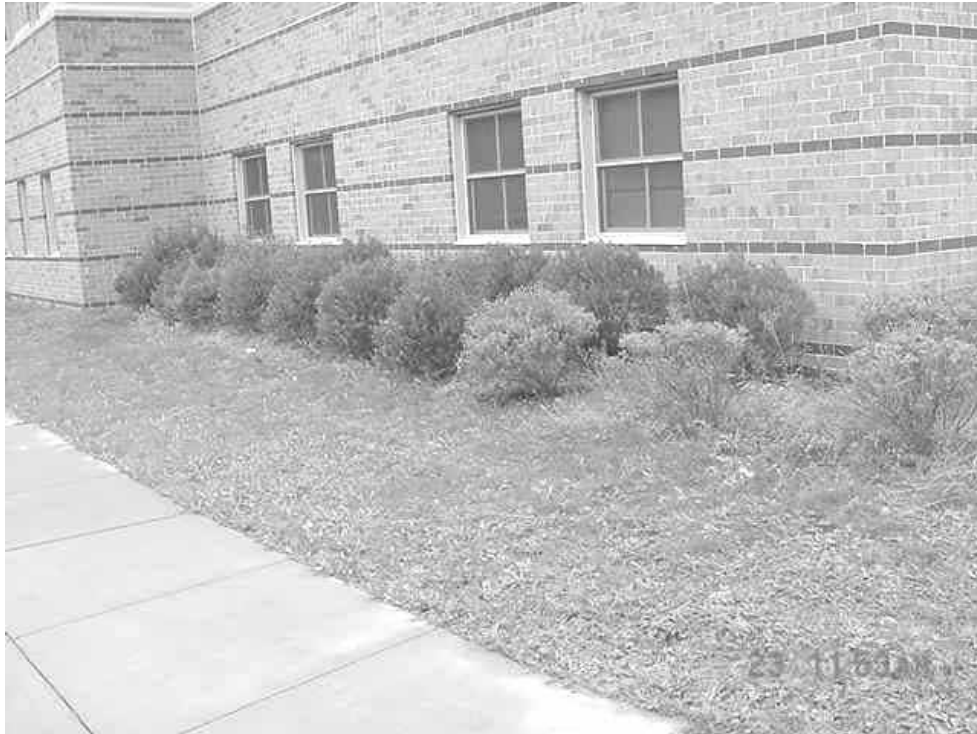
Picture 6

Shrubbery Near Exterior Brick Outside Classrooms 120-122

5. Remove plant growths against the exterior wall/foundation of the building to prevent water accumulation.
6. Clean chalkboards and dry erase board trays regularly to avoid the build-up of particulates.

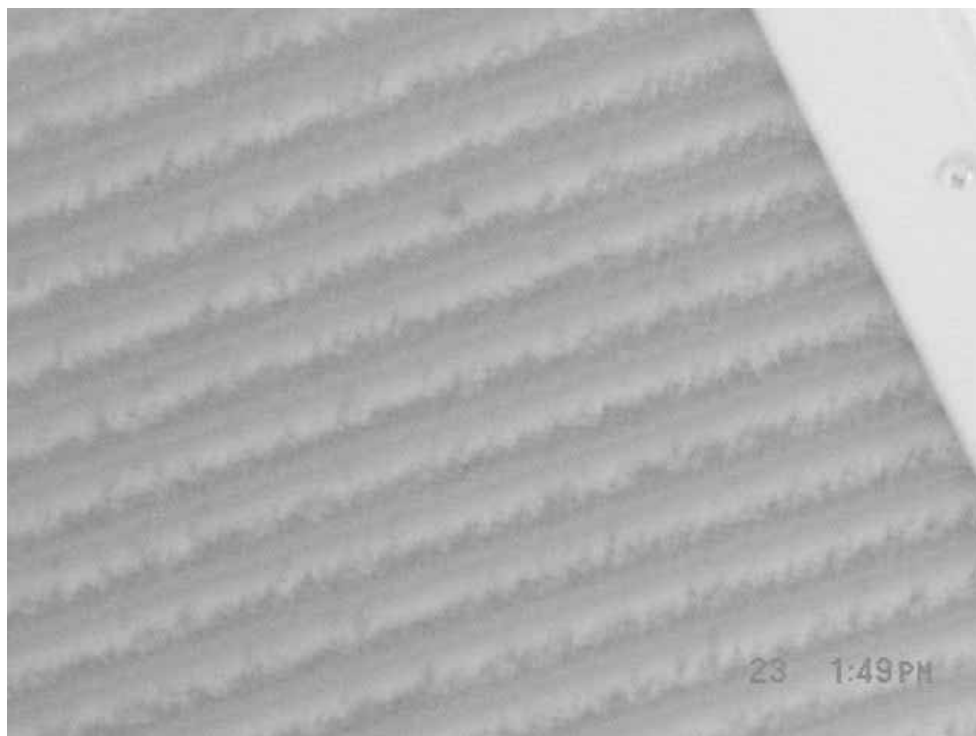
Picture 7

A number of exhaust/return vents were noted with accumulated dust (Picture 7). If exhaust vents are not functioning, backdrafting can occur, which can re-aerosolize accumulated dust particles. Classroom 328 contained a clothes dryer. BEHA staff inspected the dryer for proper ventilation and found the flexible exhaust duct was kinked, preventing proper airflow (Picture 8). Dryers must be properly vented to remove excess heat, moisture and particulates.

Return Vent With Accumulated Dust

7. Clean exhaust/return vents periodically to prevent excessive dust build-up.
8. Replace missing/dislodged ceiling tiles.
9. Reduce the length of the flexible dryer exhaust pipe to facilitate airflow.

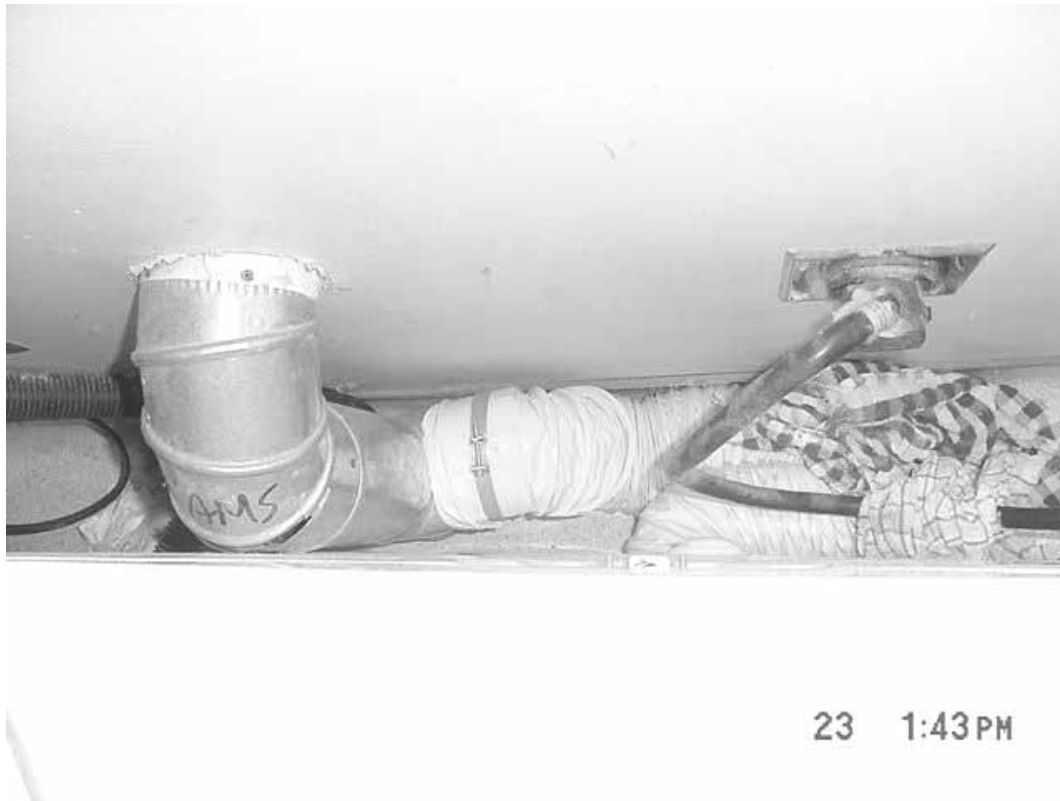
Picture 8

“Pinched” Clothes Dryer Vent in Classroom 328
